Island Barn Reservoir – Embankment Leakage remedial works

D. M. RETTURA, Atkins Ltd
M. ALESSANDRINI, Atkins Ltd
L. ABEYWICKRAMA, Costain
J. GREEN, Thames Water
B. PHILPOTT, Thames Water

SYNOPSIS Island Barn Reservoir is a non-impounding reservoir retained by an earthfill embankment that has a history of leakage. Thames Water has undertaken a Portfolio Risk Assessment identifying seepage at the reservoir as a priority remedial work activity. A Willowstick® geophysical leakage detection survey was undertaken at the reservoir and three areas of leakage were identified through the embankment and foundation. Atkins was commissioned, as part of the Eight2O alliance, to design the remedial works required to seal the leakages. As result an impermeable barrier made of steel sheet piles was assessed to be the optimal solution to form a contiguous cut-off wall to reduce the leakage.

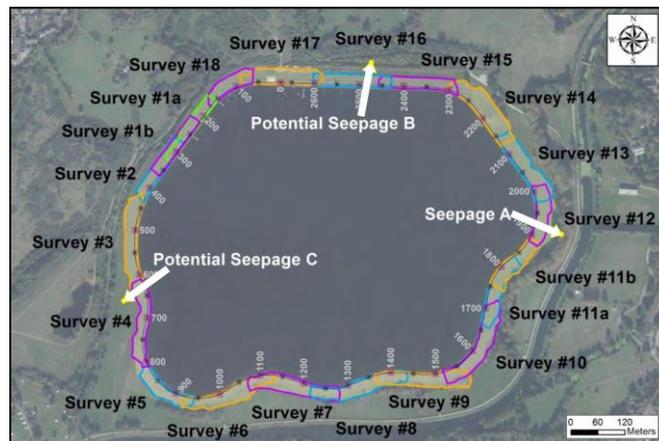
Figure 1. Willowstick Investigation – Plan View

The Willowstick survey technique identifies electric current flow paths or areas where seepage is occurring. At Island Barn, the survey showed three seepage areas, as shown in Figure 1, where a white indicates the approximate centre of the seepage path. The identified leakage was occurring through the embankment and its foundation consisting of the London Clay formation and Alluvium strata. In Area A the seepage is through the London Clay whereas in areas B and C it is through the puddle clay core (see Figure 2).

- Area A: Chainage 1,905 – 1,975, seepage path 16.2 m below the crest
- Area B: Chainage 2,450 – 2,550, seepage path 14.5 m below the crest
- Area C: Chainage 620 – 665, seepage path 14.5 m below the crest

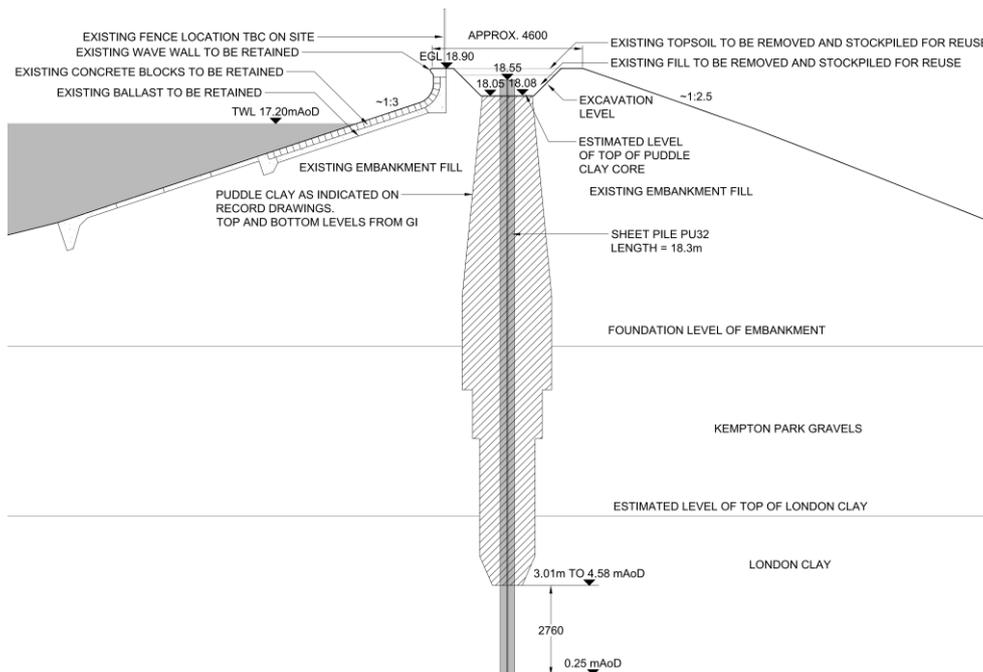
Figure 3. Dam section A – Sheet pile wall design

To ensure that the sheet piles intercepted the leakage paths a minimum penetration into the London Clay of 1.7m was specified and 18.3m long piles were chosen. The designated PU32 pile section, made of plain uncoated Grade S355GP steel, was selected based on the length of the piles and driving conditions, assessed to be: “easy” in the puddle clay core and “hard” in the underlain London clay in accordance with “Piling Handbook 9th edition” (ArcelorMittal, 2016).

When stiff London clay was encountered at the toe of the pile, water jetting was recommended via “jetting” pipes to assist installation. A procedure for

commencing the “jetting” was established to guide the installation supervision. Nevertheless, water jetting had to be avoided in the puddle clay core and for the bottom 0.5 m of the pile toe in order not to damage the soft clay core and to guarantee a water tight barrier at the toe of the pile into London clay.

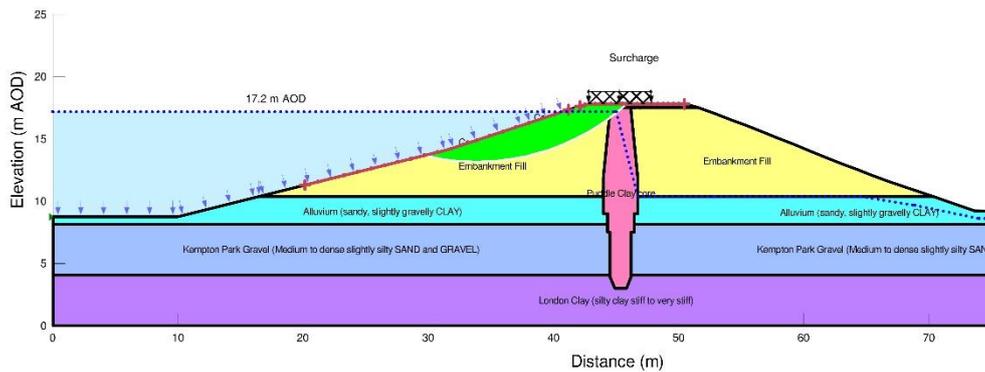
Figure 4. Dam Stability Analysis – Lowered section with working surcharge

The results of the dam stability assessment using un-factored characteristic parameters indicated that the dam is stable during the temporary works with a minimum FoS greater than 1.3. The working platform for the reaction stands consisted of 0.3m thick stone reinforced with a Tensar TriAX 160 geogrid. Figure 4 shows the dam stability analysis for the lowered section subjected to working surcharge. The tracking platform to allow safe transit over the crest consisted of 0.2m thick stone reinforced with a Tensar TriAX 160 geogrid. Figure 5 shows the dam stability analysis for the original section subjected to tracking surcharge.

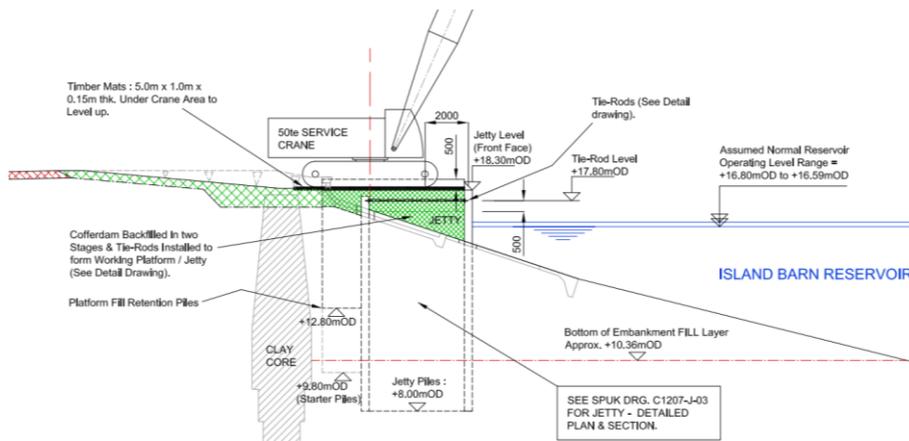
Figure 6. Jetty and Plateau (Extracted from Sheet Piling UK drawing)

The jetty was constructed to launch the pontoon onto the reservoir, to load the plant on to the pontoon, and to facilitate the installation of sheet piles from the water. The jetty consisted of a 4-sided rectangular cofferdam made of sheet piles, protruding from the crest wave wall into the reservoir and filled with graded granular material (See Figure 6). Its stability was assessed with the finite element software PLAXIS 2D. The maximum loading pressure considered for the analysis was related to the 50-tonne crawler crane which gave the highest bearing pressure.

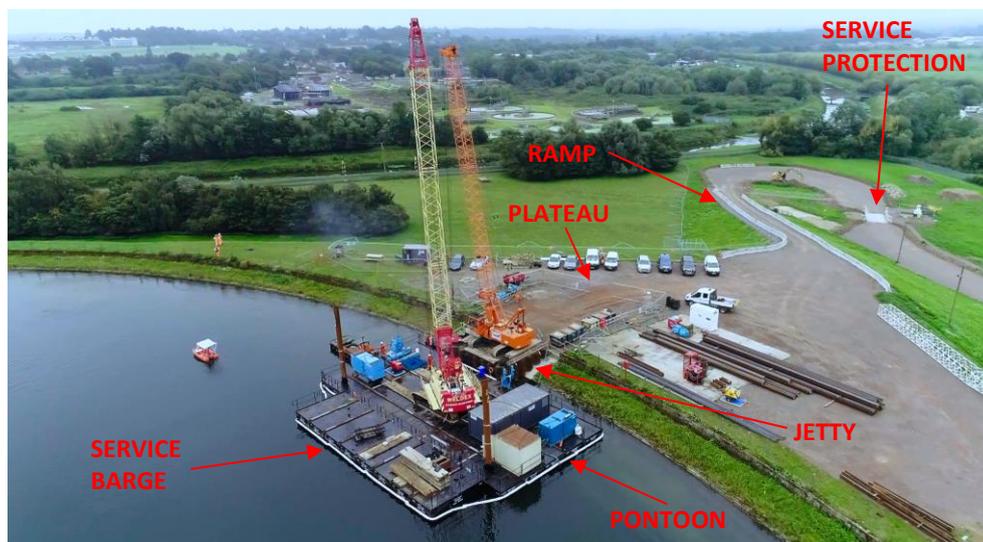
Figure 7. Access, Jetty, Plateau and Pontoon

The approach to the construction site includes the access ramp, plateau, jetty and pontoon launch as shown in Figure 7.
